PROGRAM FOR THE DEVELOPMENT OF A SUPERCONDUCTING GENERATOR

Westinghouse Electric Corporation Aerospace Electrical Division Lima, Ohio 45802

Technical Report AFAPL-TR-79-2012 Final Report for Period January 1974 to January 1979

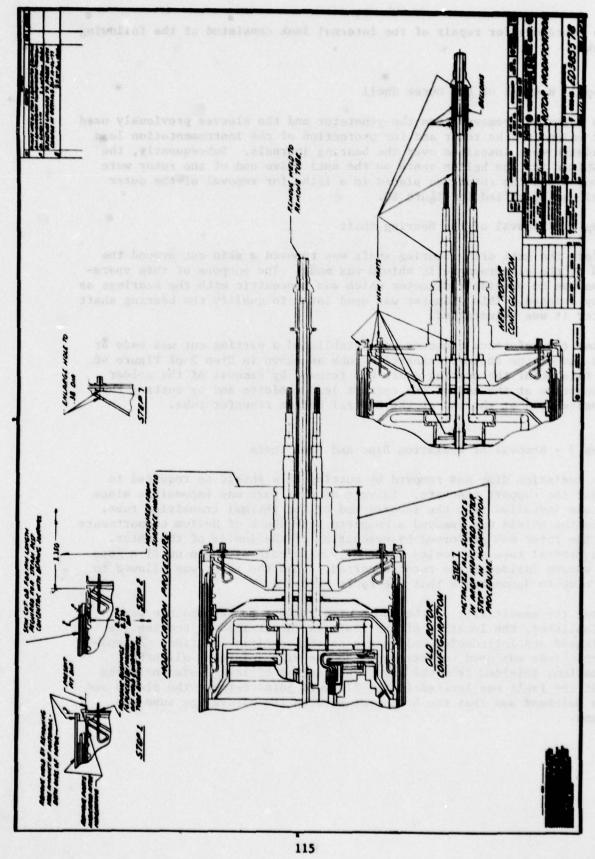
FIGURE 40. Rotor Repair Drawing for Internal Transfer Line

A series of leak tests were performed to establish the nature and location of the leak. It was concluded that the fault was located in or about the bulk head on the anti-drive end at a point near the penetration of the central heluim transfer tube into the low temperature structure. Also, it was established from these experiments that the fault did not leak until the bulk head was cold.

It was concluded that a repair of the internal leak could be performed and at the same time improve the design of the central transfer line. The improvement consisted of an Inconel tube for both the transfer tube and the warm outer tube. The inboard end of the transfer tube would be welded to an Inconel flange which would in turn would be welded to the bulk head. This flange would surround the previous faulty joint. An Inconel bellows would be incorporated to accommodate the relative thermal contraction of the warm structure and the cold inner tube. The modification of the rotor for incorporation of the improved design is shown in Figure 40.

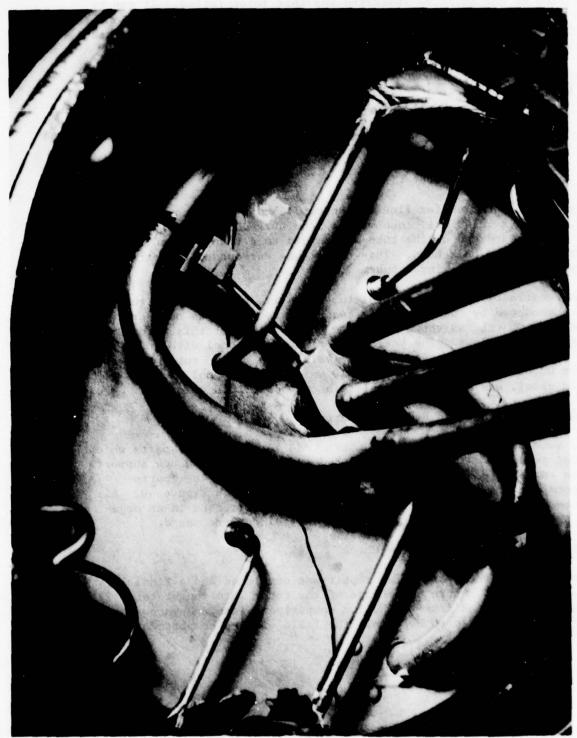
FIG. 42 New Support for Current Leads

FIG. 41 Failure of Support Clamp for a Current Lead Conduit

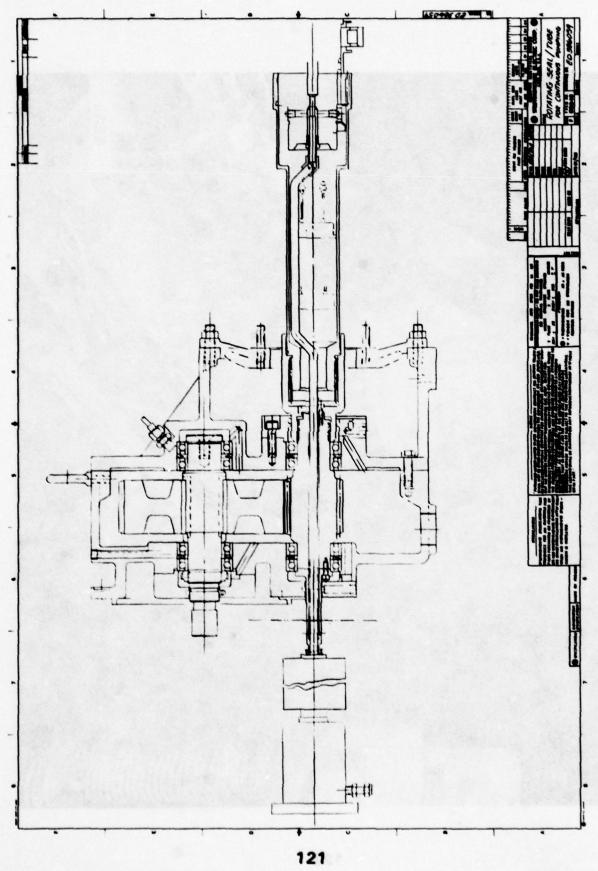
FIG. 43 Configuration of Continuous Pumping System

Therefore, the rotor was removed and a calibration of the conductance of the vacuum pump-down line was made. This calibration consisted of measuring the vacuum pressure at the union for the pump-down line and the rotor versus the pressure at the vacuum pump for different helium leakage rate through the line. With this calibration and the pressures observed at the vacuum pump during the cool-down, it was established that pressures between 10⁻³ and 10⁻²mmHg existed in the vacuum compartment of the rotor during the previous cool-down cycle. These pressures were approximately 10 times greater than the allowable vacuum pressure for acceptable gas conduction losses.

The configuration of continous pumping system is shown in Figure 43 and a photograph of the installation from behind the gear box is shown in Figure 44.

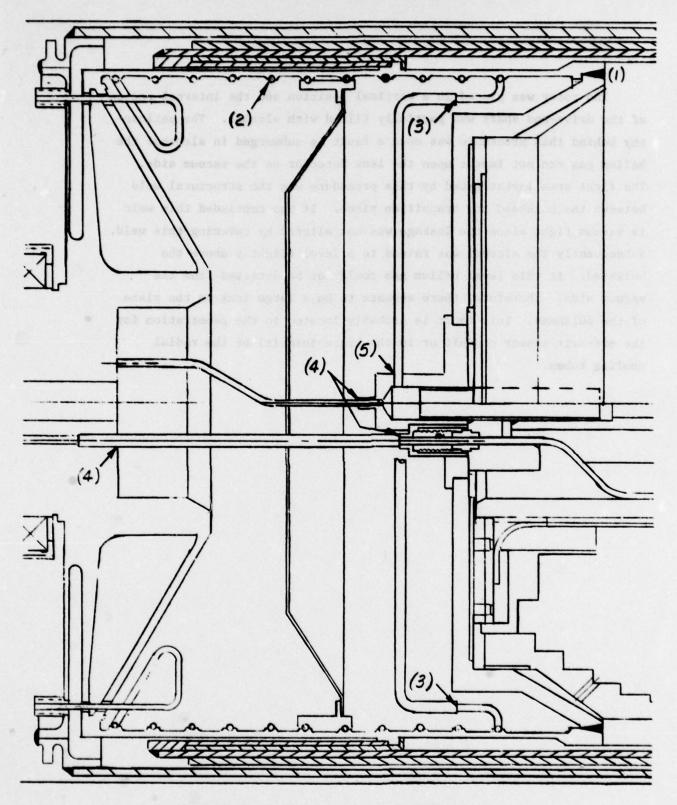
FIGURE 48 INTERIOR OF DRIVE-END SHAFT

USAF approval was obtained on 11/29/78 to remove the outer shell and electrothermal shield and to perform leak tests to define the area(s) of leakage. The internal region of the drive-end shaft showed a significant leakage into the field winding compartment when helium gas was introduced from the outside. The location of this leak was isolated from other areas by partially filling the hollow shaft with liquid (alcohol) and checking with helium gas above the liquid. This leak is located at the level of the central bulkhead. Two possible areas exits for the leak. They are: (1) the braze joint(s) between the radial conduits and the cooling coils on the thermal transition tube, and (2) at or near the bulkhead penetration of a lead conduit for resistance thermometers. A second leak was found inboard of a terminal brazement for a helium conduit and the anti drive-end shaft. Extensive disassembly of the rotor is required to repair these faults.

Further checks proved the bulkhead, helium supply line, cooling coils and current lead conduits were vacuum tight. Thirdly, helium gas was introduced into the interior region of the drive-end shaft. This region showed a significant leak of helium into the field winding compartment. The exact location of the leak(s) could not be defined since the helium gas was exposed simutaneously to several critical areas. The areas of particular concern are noted in Figure 48. They included (1) the weld around the bulkhead and the thermal transition piece, (2) the cooling coils on the transition piece, (3) the joints between the cooling coils and radial conduits, (4) the conduits for the sensor leads, and (5) the brazements for the tube terminals at the center of the bulkhead. In order to individually investigate the integrity of one of these areas it is necessary to disassemble other areas of concern. Therefore another option was selected to further isolate the fault(s).
